Multiple Skip (M-Skip®) is an advanced ultrasonic inspection method used for inspection of areas of pipes, risers, and vessels rendered inaccessible by obstructions such as supports, clamps, and saddles. This ultrasonic pitch/catch method that allows probe placement either side of an obstruction at separation distances of up to 5.25 ft (1.6 m).

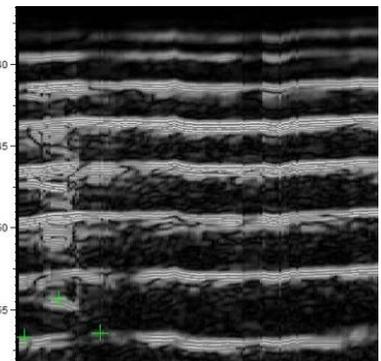
M-skip analysed data showing defect on left side

Ultrasound is transmitted through the wall of the pipeline, beneath the external obstruction and is received on the far side. The ultrasonic waves 'skip' between the internal and external surfaces and the arrival times of the signals are used to calculate wall thickness. Corrosion is detected through loss of signal amplitude, reduced signal arrival times and changes to signal shape.

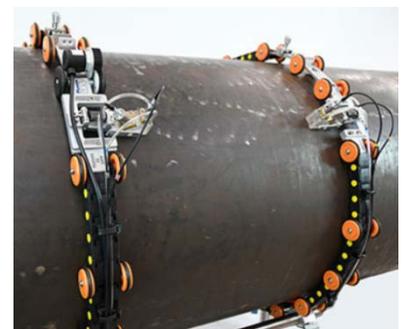
M-skip scanner setup

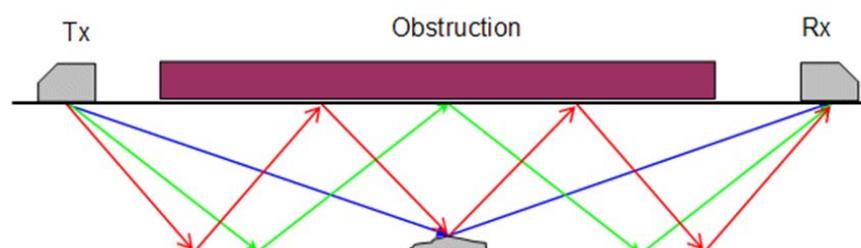
e.g., M-skip beam pattern demonstration such as a saddle support.
